**AIR FORCE FLIGHT  
EVALUATION (SYSTEMS)  
OF THE  
A-10A PROTOTYPE AIRCRAFT**

**TECHNICAL REPORT No. 73-3**

**MARCH 1973**

**AIR FORCE FLIGHT TEST CENTER  
EDWARDS AIR FORCE BASE, CALIFORNIA  
AIR FORCE SYSTEMS COMMAND  
UNITED STATES AIR FORCE**

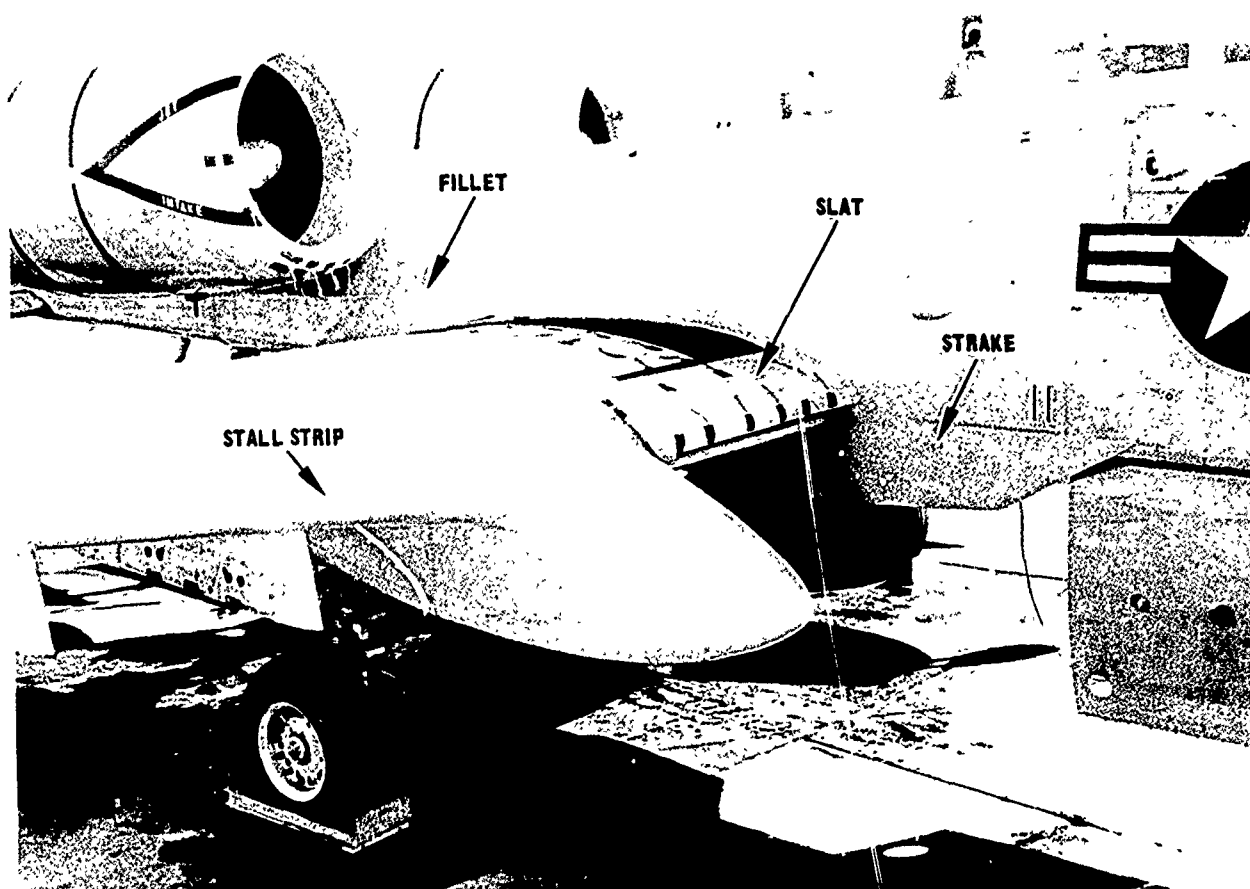
Figure 1

Tests were conducted after completion of Task II to evaluate contractor modification of the A-10A airframe as a solution to the YTF34 engine/A-10A airframe incompatibility problem. This deficiency was documented in the Propulsion-Normal Operations section of the Systems Evaluation Test Results. The modifications consisted of several aerodynamic changes to the A-10A airframe. A fixed, single slotted leading edge slat was installed on the inboard section of each wing between the fuselage and the main landing gear pod. A 24 inch wing leading edge stall strip was located approximately one and a half feet outboard of each gear pod. Also, a filet between the wing and the fuselage at the aft wing root was added. Lastly, a vertical strake was mounted on the fuselage forward of and just below each wing. The complete configuration is shown in Figure 1.
